Service Instructions

Order Nr. 190.0101b

BASIC	036
MEDIAN	046
DOMINANT	056

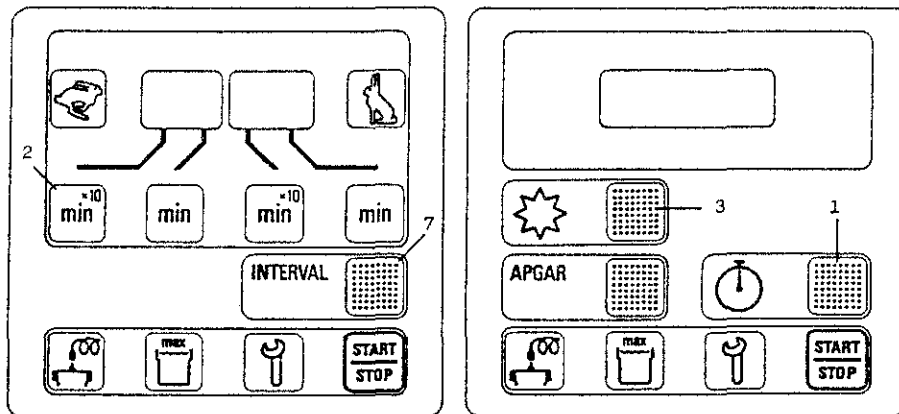
A. The "Start/stop" key does not function:

- Check fuses (L). The main switch (K) must be set to "ON".
- Probably, keys (7) and (2) on the low vacuum pump resp. (1) and (3) on the vacuum extractor were pressed simultaneously by mistake. This programs the electronics to a help setting for servicing purposes and eliminates normal control functions.

Press the key (7) resp. key (1) three times. The pump can now be controlled again using the "Start/stop" key.

B. Models with a liquid crystal display: (see illustration p. 13)

- Press keys (7) and (2) on the low vacuum pump resp. (1) and (3) on the vacuum extractor simultaneously. An "S" for "Service" will now appear on the display. When released, a symbolic "G" (reason for the alarm) will appear, together with a number with the following meaning:

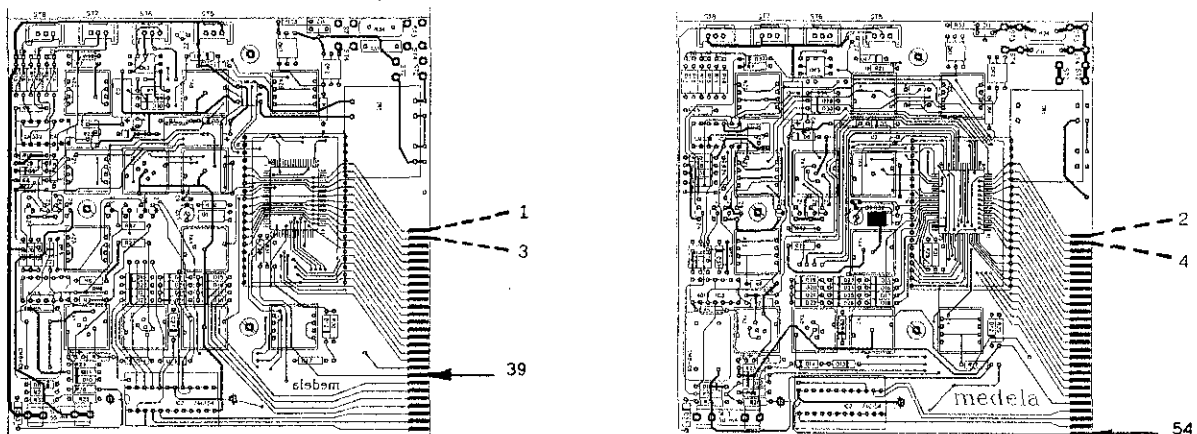
B. Electronics indicate other malfunctions:

- It is possible that the programming has been affected by a voltage peak in the mains supply.
- Connect the unit to the mains supply. Set switch (K) set to "ON"
- Briefly short-circuit PCB-connections 39 and 54. This resetting operation is acknowledged by means of an acoustic signal.
- If the electronic system does not return to normal operation even after this has been done, the circuit board must be replaced. Prior to restarting, the resetting operation described above must also be carried out first (shorting PCB- connections 39/54).
